# Flood Adaptation and Water Management in the areas of Yorkton, Saskatchewan: A Case Study

Vanessia Romo Almanza  
Chemical Engineering Student  
Universidad Veracruzana

Dr. Margot Hurlbert  
Johnson Shoyama Graduate School of Public Policy  
University of Regina

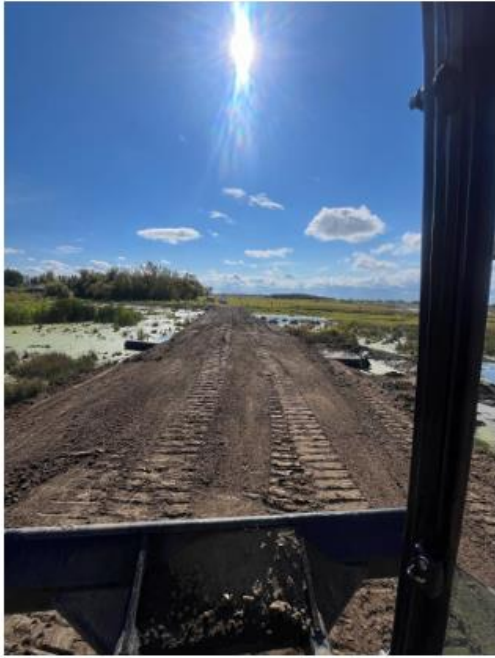
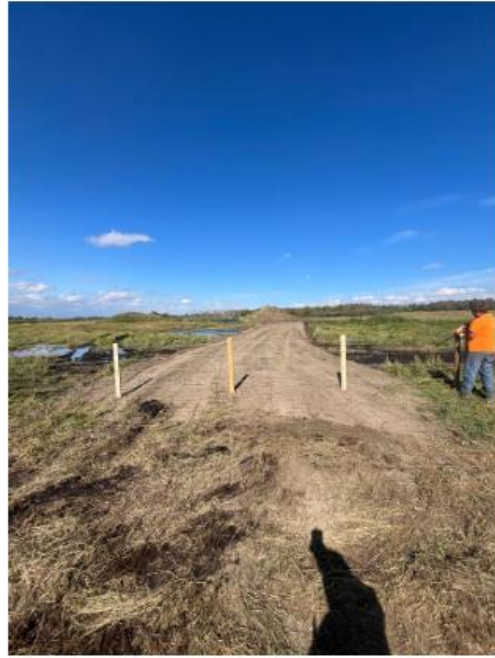
**Figure 2**  
**Berm construction at Crescent Creek, September 2024.**

A project at Crescent Creek created an overflow channel that allows high water to bypass the main beaver dam. The work improved water conveyance while retaining the beaver pond and associated habitat. This represented a practical adaptation that combined flood mitigation with the landowner's interest in habitat conservation (AWSA, 2026, p. 21).

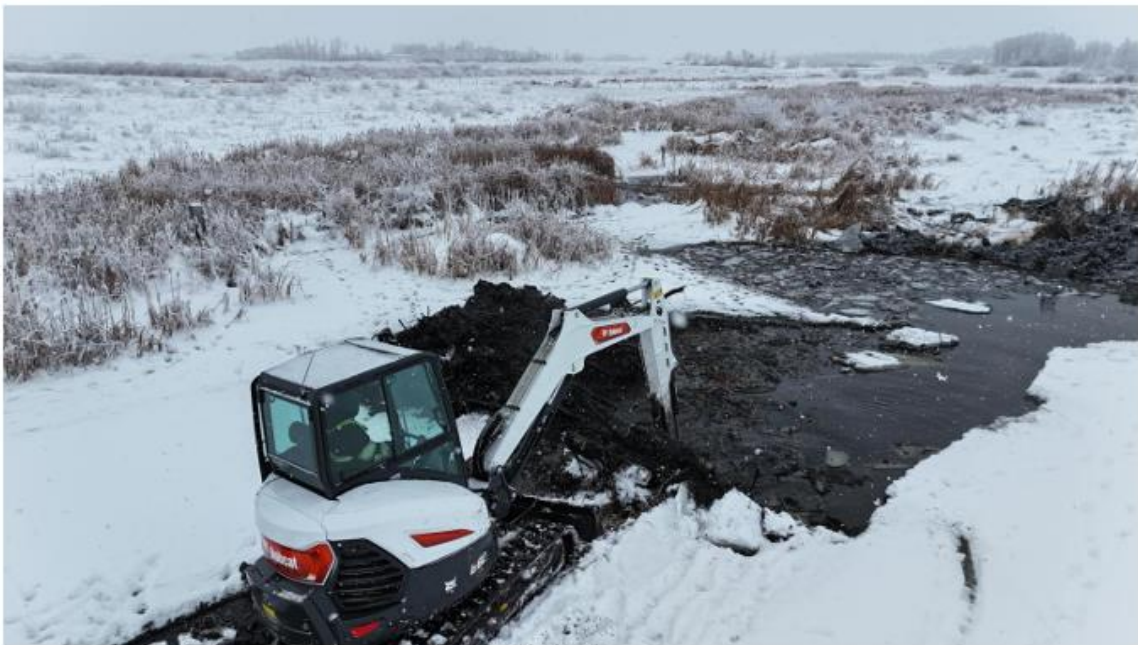
**Figure 3**  
**Removal of the secondary dam at Crescent Creek, November 2024.**
